## Memorandum

To: Chapter Members/Volunteers/Concerned Parties  
From: Central NY Chapter—NCTA Newsletter Editor, Al Larman  
Subject: New York Parks — Unilaterally Imposed Actions

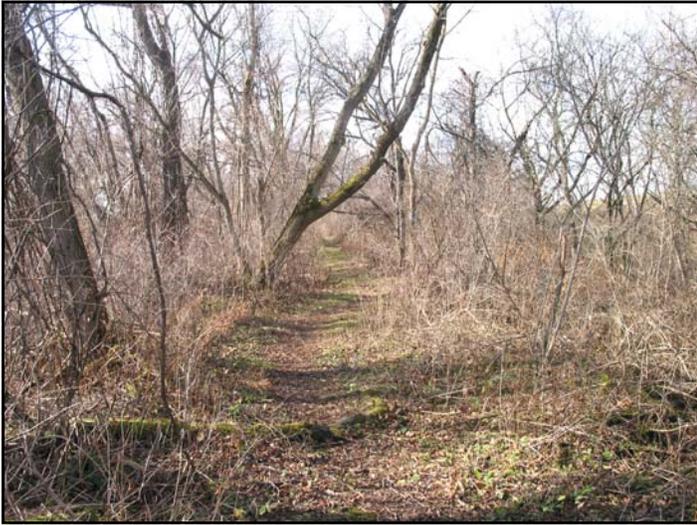
Representative example— foot trail west of Nelson Road. Trees and brush provided soil stabilization—buffered noise and winds—a four season trail segment.

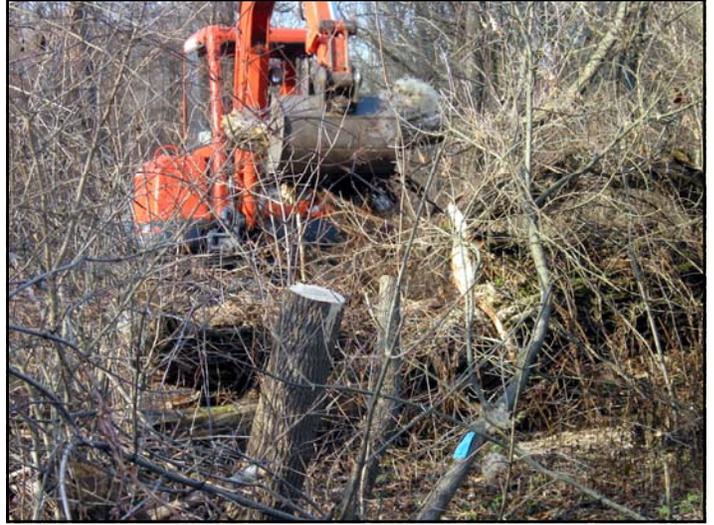
Chain saw crew cut trees ahead of excavator & brush-hog- Note logs, brush, and soil being dumped into adjacent drainage ditches .

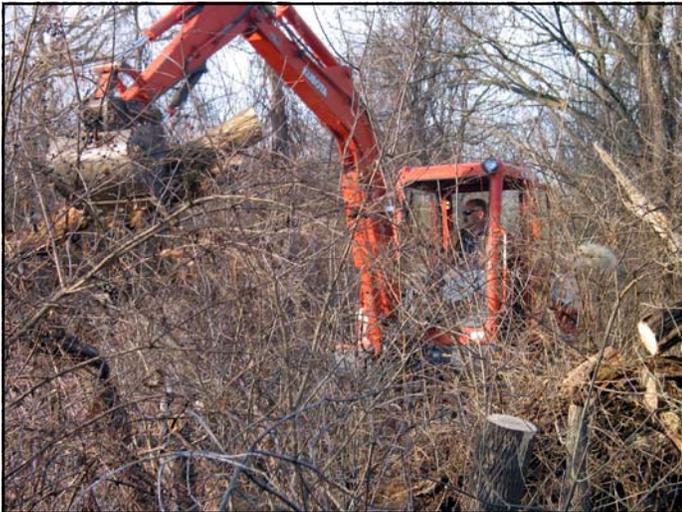
Left Photo)View west from Nelson Road toward Harp Road—note tree and brush cuttings, plus base material from old rail-bed, dumped into adjacent drainage ditch.

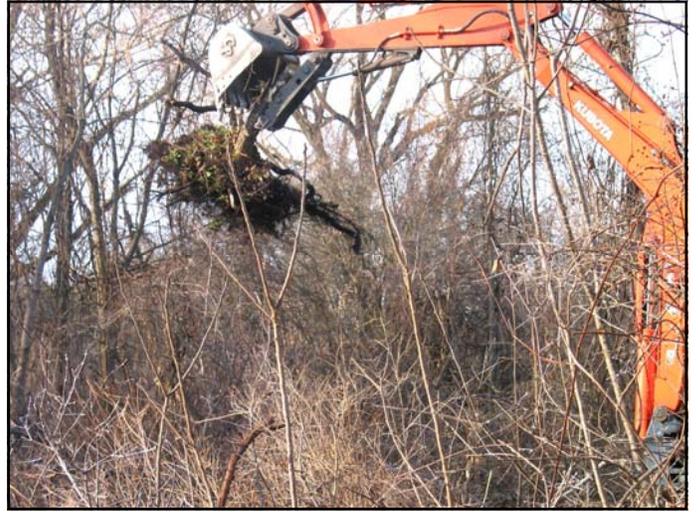
(Right Photo)—view is westward from Harp Road. The cut width ranges from 15-25+ feet, far more than the space needed for modest speed snowmobile use.

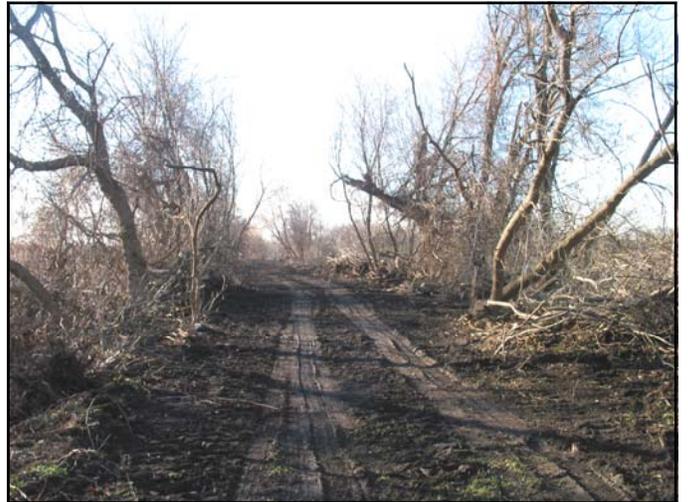
The trail is now devoid of attractions, protection from winds, and has drainage ditches littered with brush and cut trees. Truck traffic reportedly attributable to Tri Valley “maintenance personnel” is apparent. An apt term for the result is “road”.

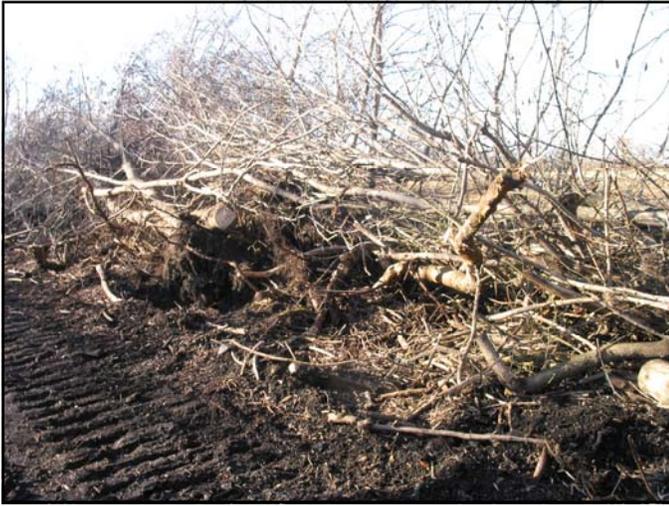
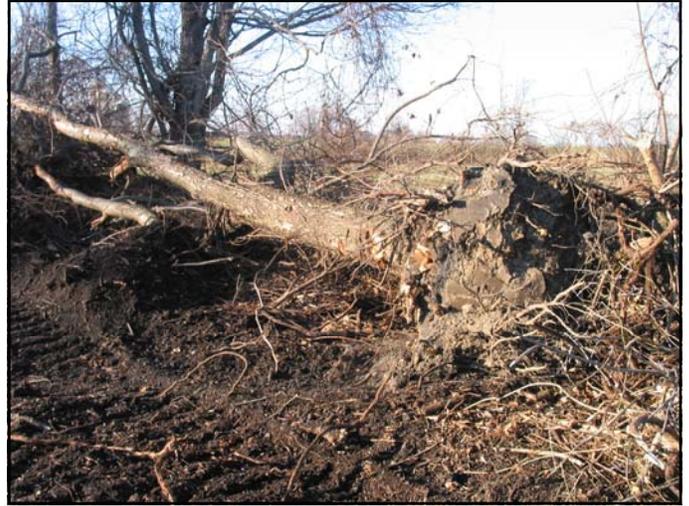
( above) Area just west of Harp Road—large pile of cut trees and brush—note large tree uprooted during clearing operations.

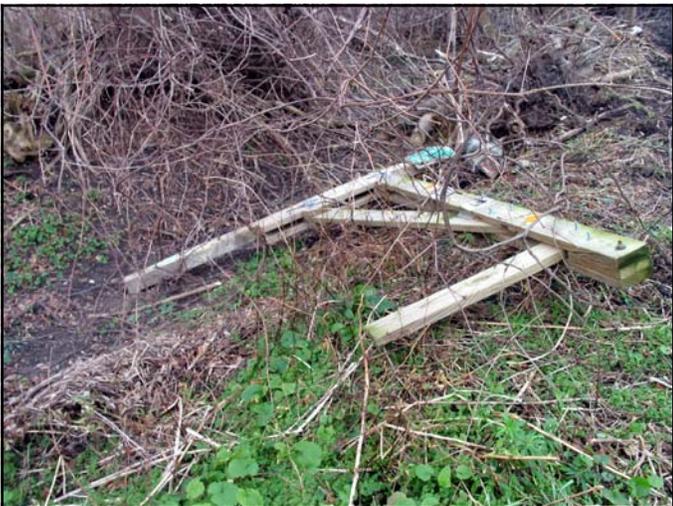
(Above) one of several gates torn down —thrown in the drainage at Harp Road—other debris in ditch nearby. (Gate since salvaged by CNY-NCTA)

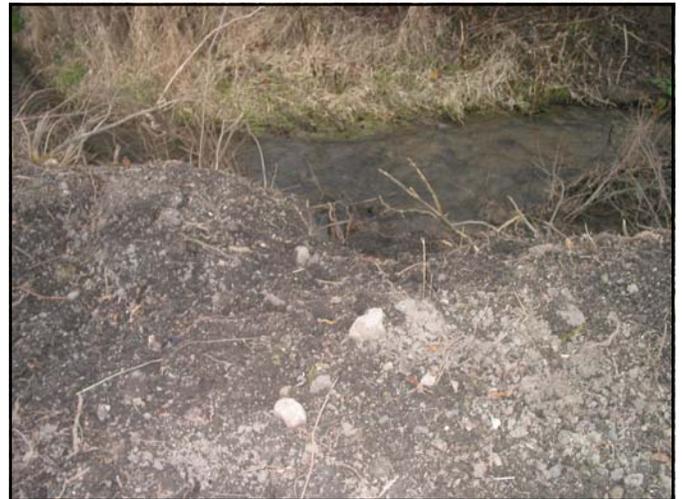
Example—bulldozed rail-bed material positioned at edge of bank of Canastota Creek—unstable situation.

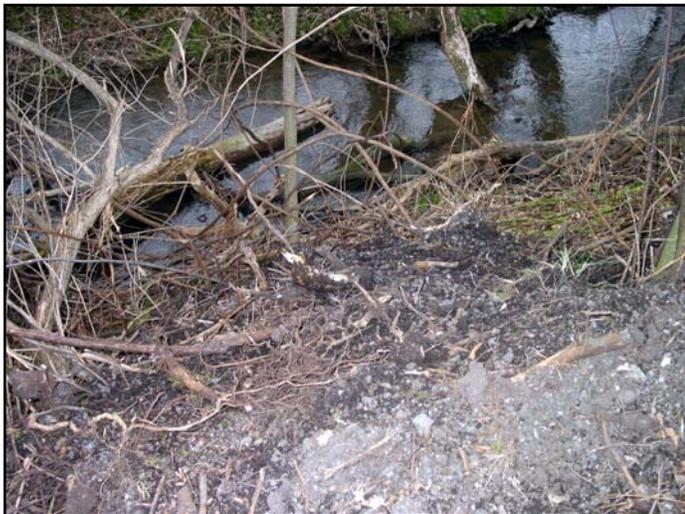
Another example of potential runoff from the disturbed soil into Canastota Creek on the section from Nelson Road westward for hundreds of feet. Canastota Creek on the north and a tributary stream on the south have strong flows at times. With tree, vines, and brush roots removed or disturbed, erosion issues are likely occurrences.
